ARCHITECTURE

EHLINGER & ASSOCIATES

FIRST QUARTER 2011

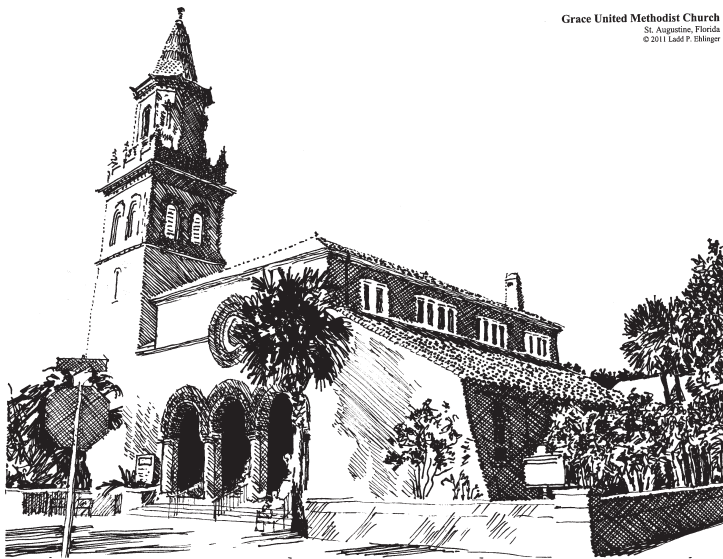
Grace United Methodist Church
St. Augustine, Florida
© 2011 Ladd P. Ehlinger

Grace United Methodist Church in St. Augustine, Florida, this issue's limited edition print of a sketch by Ladd P. Ehlinger has a very interesting history, besides being an archetype of what I would call "Robber Baron Architecture". This building is actually the second building the congregation had designed and built. The first was built in 1884 and was closer to the Ponce de Leon Hotel being built by Henry Flagler. Shortly after completion, Flagler decided that he needed the property to further complete the hotel, so he offered in 1886 to buy the first building and furnish property and build a new church further north on Cordova St. at Carrera in St. Augustine. The congregation accepted Flagler's offer, and work began on the new facility in 1886.
