ARCHITECTURE

EHLINGER & ASSOCIATES

FIRST QUARTER 2008

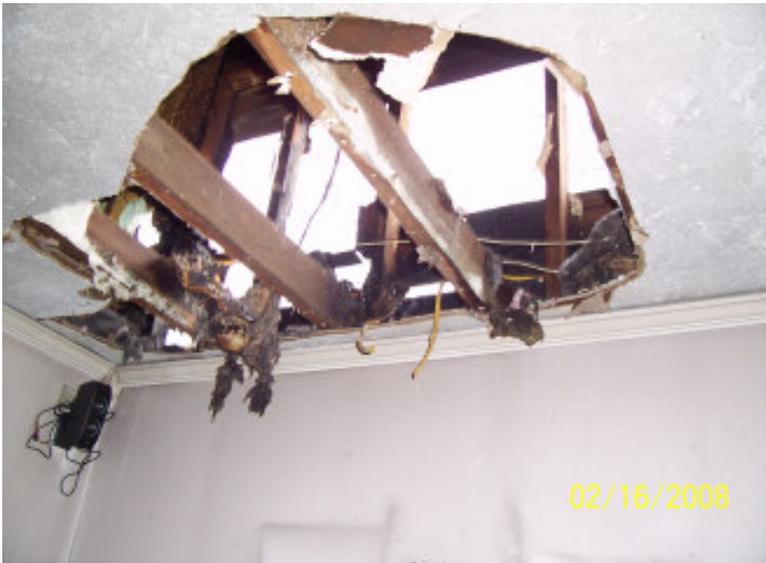
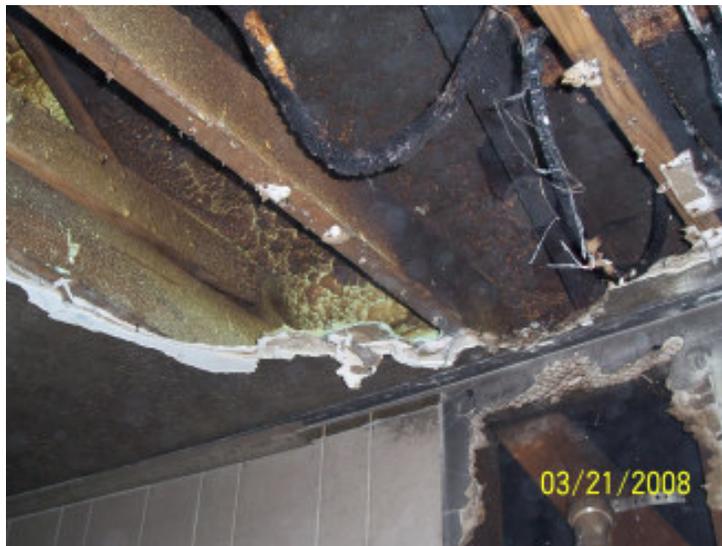
with the foam, as I'd planned to remove the vent and replace it with a window. This area was completely charred to a crisp.

Where the foam was sprayed,

though, was very surprising. I would have expected the foam itself to catch fire and act as a fuel source, but that's not what happened. While the flames clearly entered the attic to a depth of about 10 feet, none of the roof caught fire. Instead, the foam appears to have bubbled away - literally evaporated, rather than catch fire. This evaporation kept the wood joists and decking from catching fire, protecting it and the rest of the house. The foam had evaporated to a depth of about 3 feet from the outside wall, and some of the rafters were charred on the edges that the foam didn't cover, but clearly hadn't burned through.

closed-cell polyurethane insulating foam that I'd sprayed in my attic. I'd chosen to use this material because the roof deck of the attic in the main house was tongue and groove planking, with most of them missing the tongue and groove. During hard rains, water could blow in under the shingles and leak into the house. The closed-cell insulation is waterproof, and filled all of the cracks, preventing leaks as well as insulating the house. After two years, it had paid for itself in reduced power bills, allowed the attic to be used during any season, and prevented any number of spot leaks around the house. I was quite pleased with it.

Now, the attic from the addition was open to the attic of the main house. Where it was attached, from the floor of the attic to about 2 feet up where the addition's roof attached, was open to the main attic, so flames were entering the attic of the main house directly without having to burn through anything.

Above this connection, the gable wall of the main attic was only partially sprayed
