ARCHITECTURE

EHLINGER & ASSOCAITES

SECOND QUARTER 1990

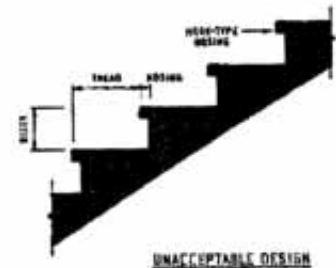
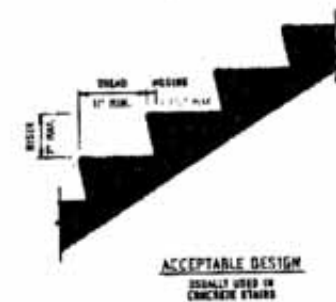
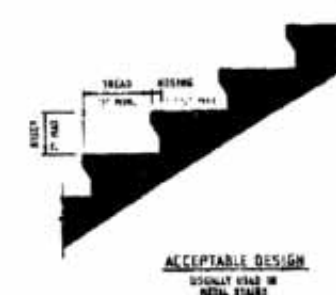
Non-impaired (normal) walkers actually walk with a somewhat shuffling motion, with the feet advancing and retreating more than they actually have to, to maintain a walking rhythm. The nosing on a stair provides a space for the toe forward projected motion on the way up the stairs, and for the heel projected motion on the way down the stairs. Stairs with no nosings will be a trip hazard for normal walkers, stubbing the toe on the way up, and propelling the heel on the way down, both causing a loss of footing and a fall. The compromise is to design a nosing at an angle, such that the impaired and non-impaired walkers are both accommodated, (no hook hazard and a space for the foot movement) per the illustration.

All risers (height of the steps) of a stair should each be the same dimension within a tolerance of $1/8'' \pm$ as should each of the treads (width of the steps). This facilitates the rhythm of walking. An abrupt change of these dimensions from one step to the next will disrupt the rhythm and produce a trip. The Life Safety Code, which is adopted by most all building codes in the United States, prescribes that the maximum height of a riser in a building with public access should be 7'' and that the width of the tread should be no less than 11''.

The Life Safety Code recommends that no nosing (the part of the tread that overhangs the riser below) be used at all, or if used that there be no hook hazard for the handicapped. The thinking is that walking impaired people 'hook' the toe of their shoes on nosings. This is a change also from previous standards, and is the subject of much contention and debate for the following reasons.
